Photo Album

Colorado County Interior Restoration

2012 – 2013

Part 1

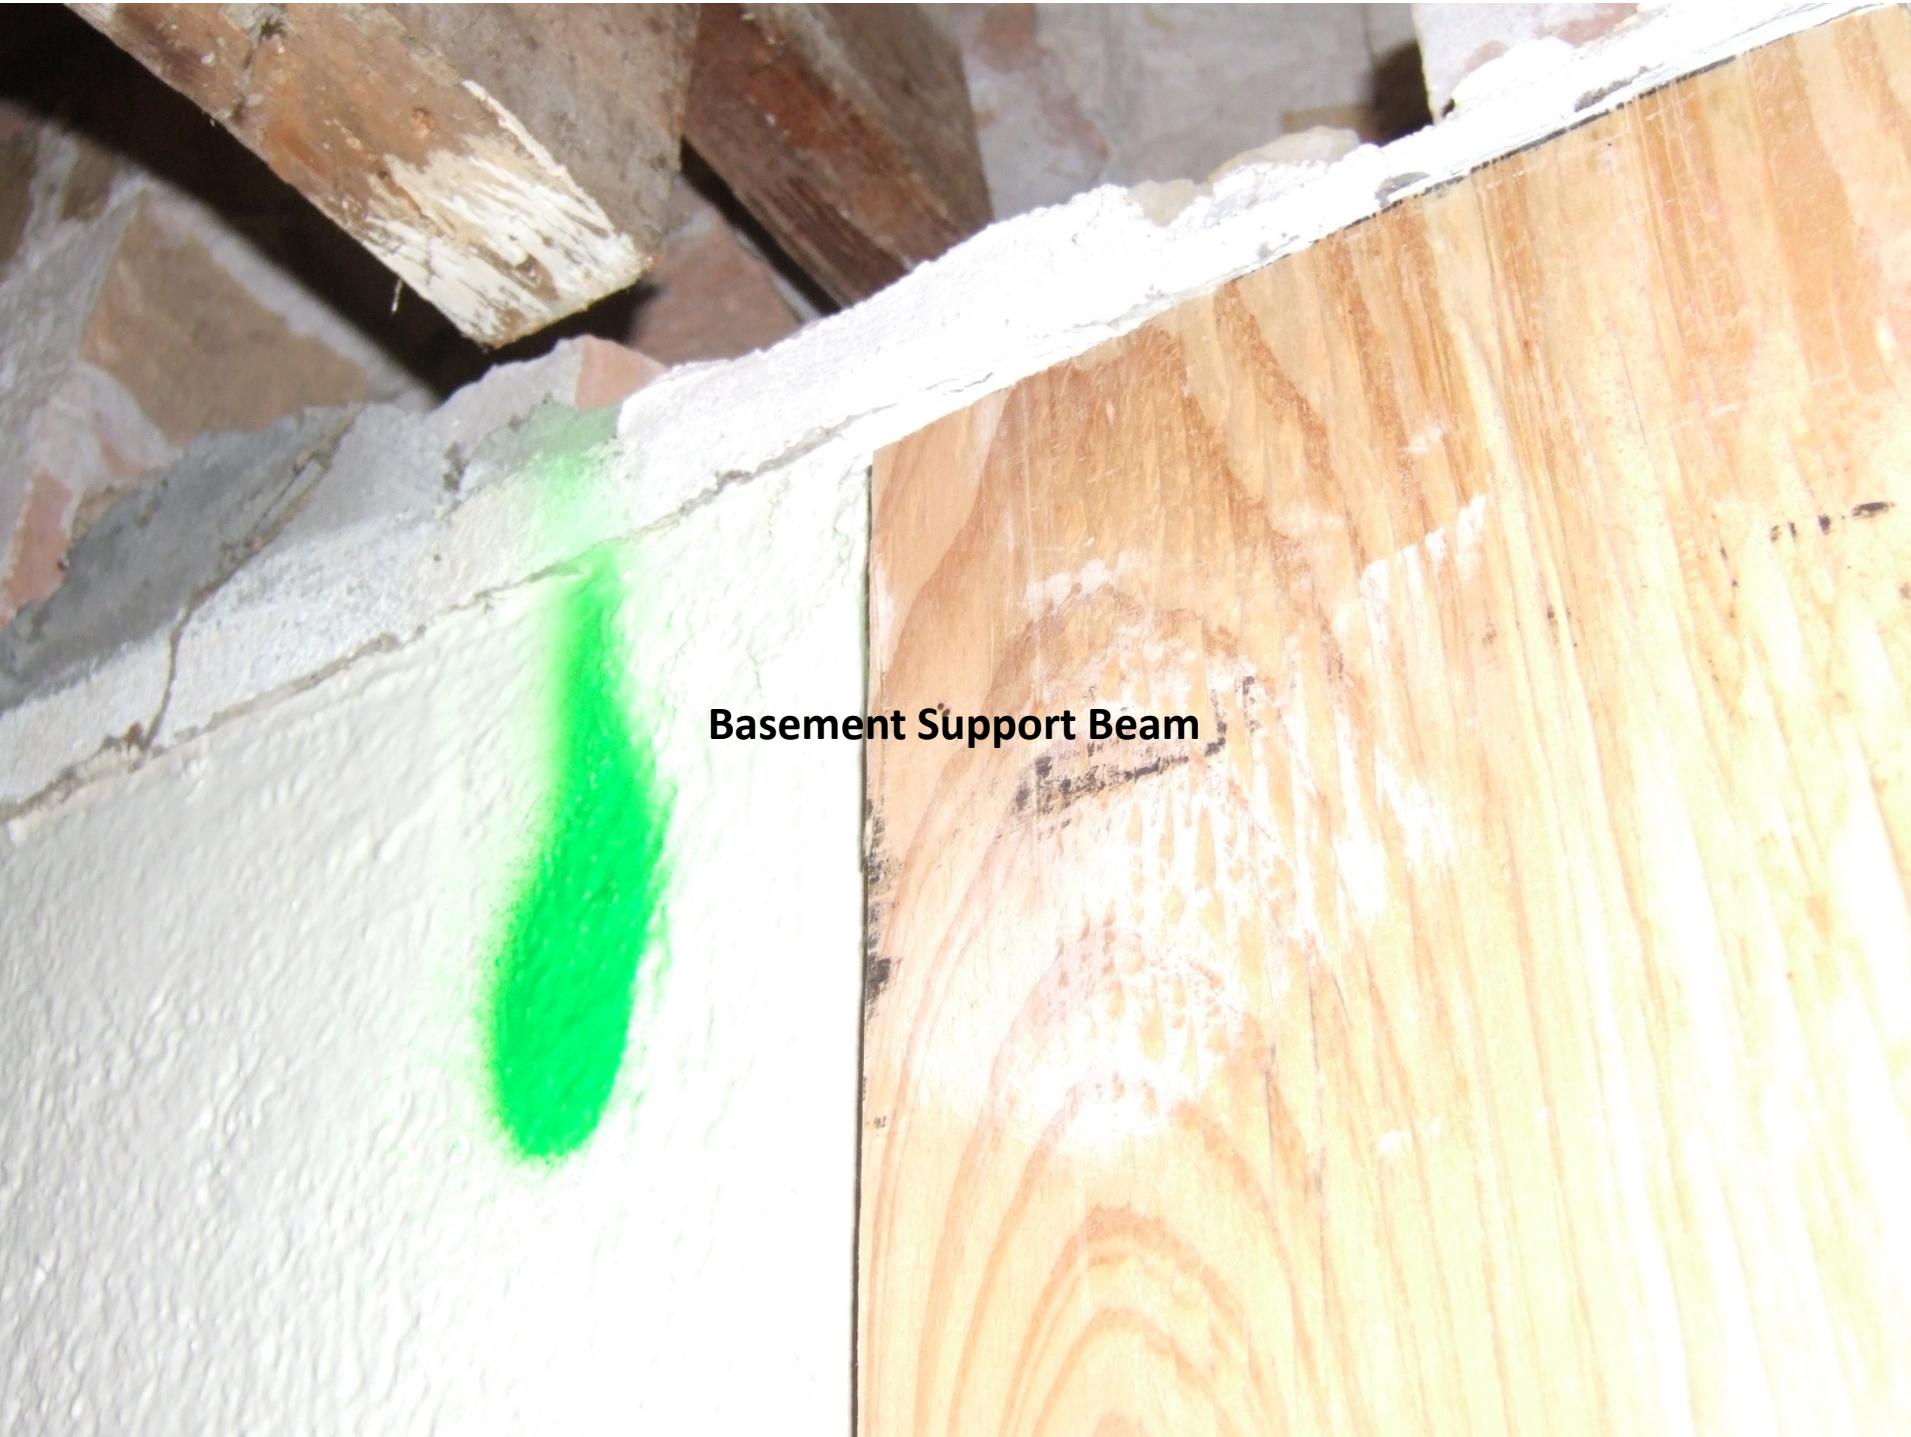
Basement – Bracing & Damaged Floor Joist

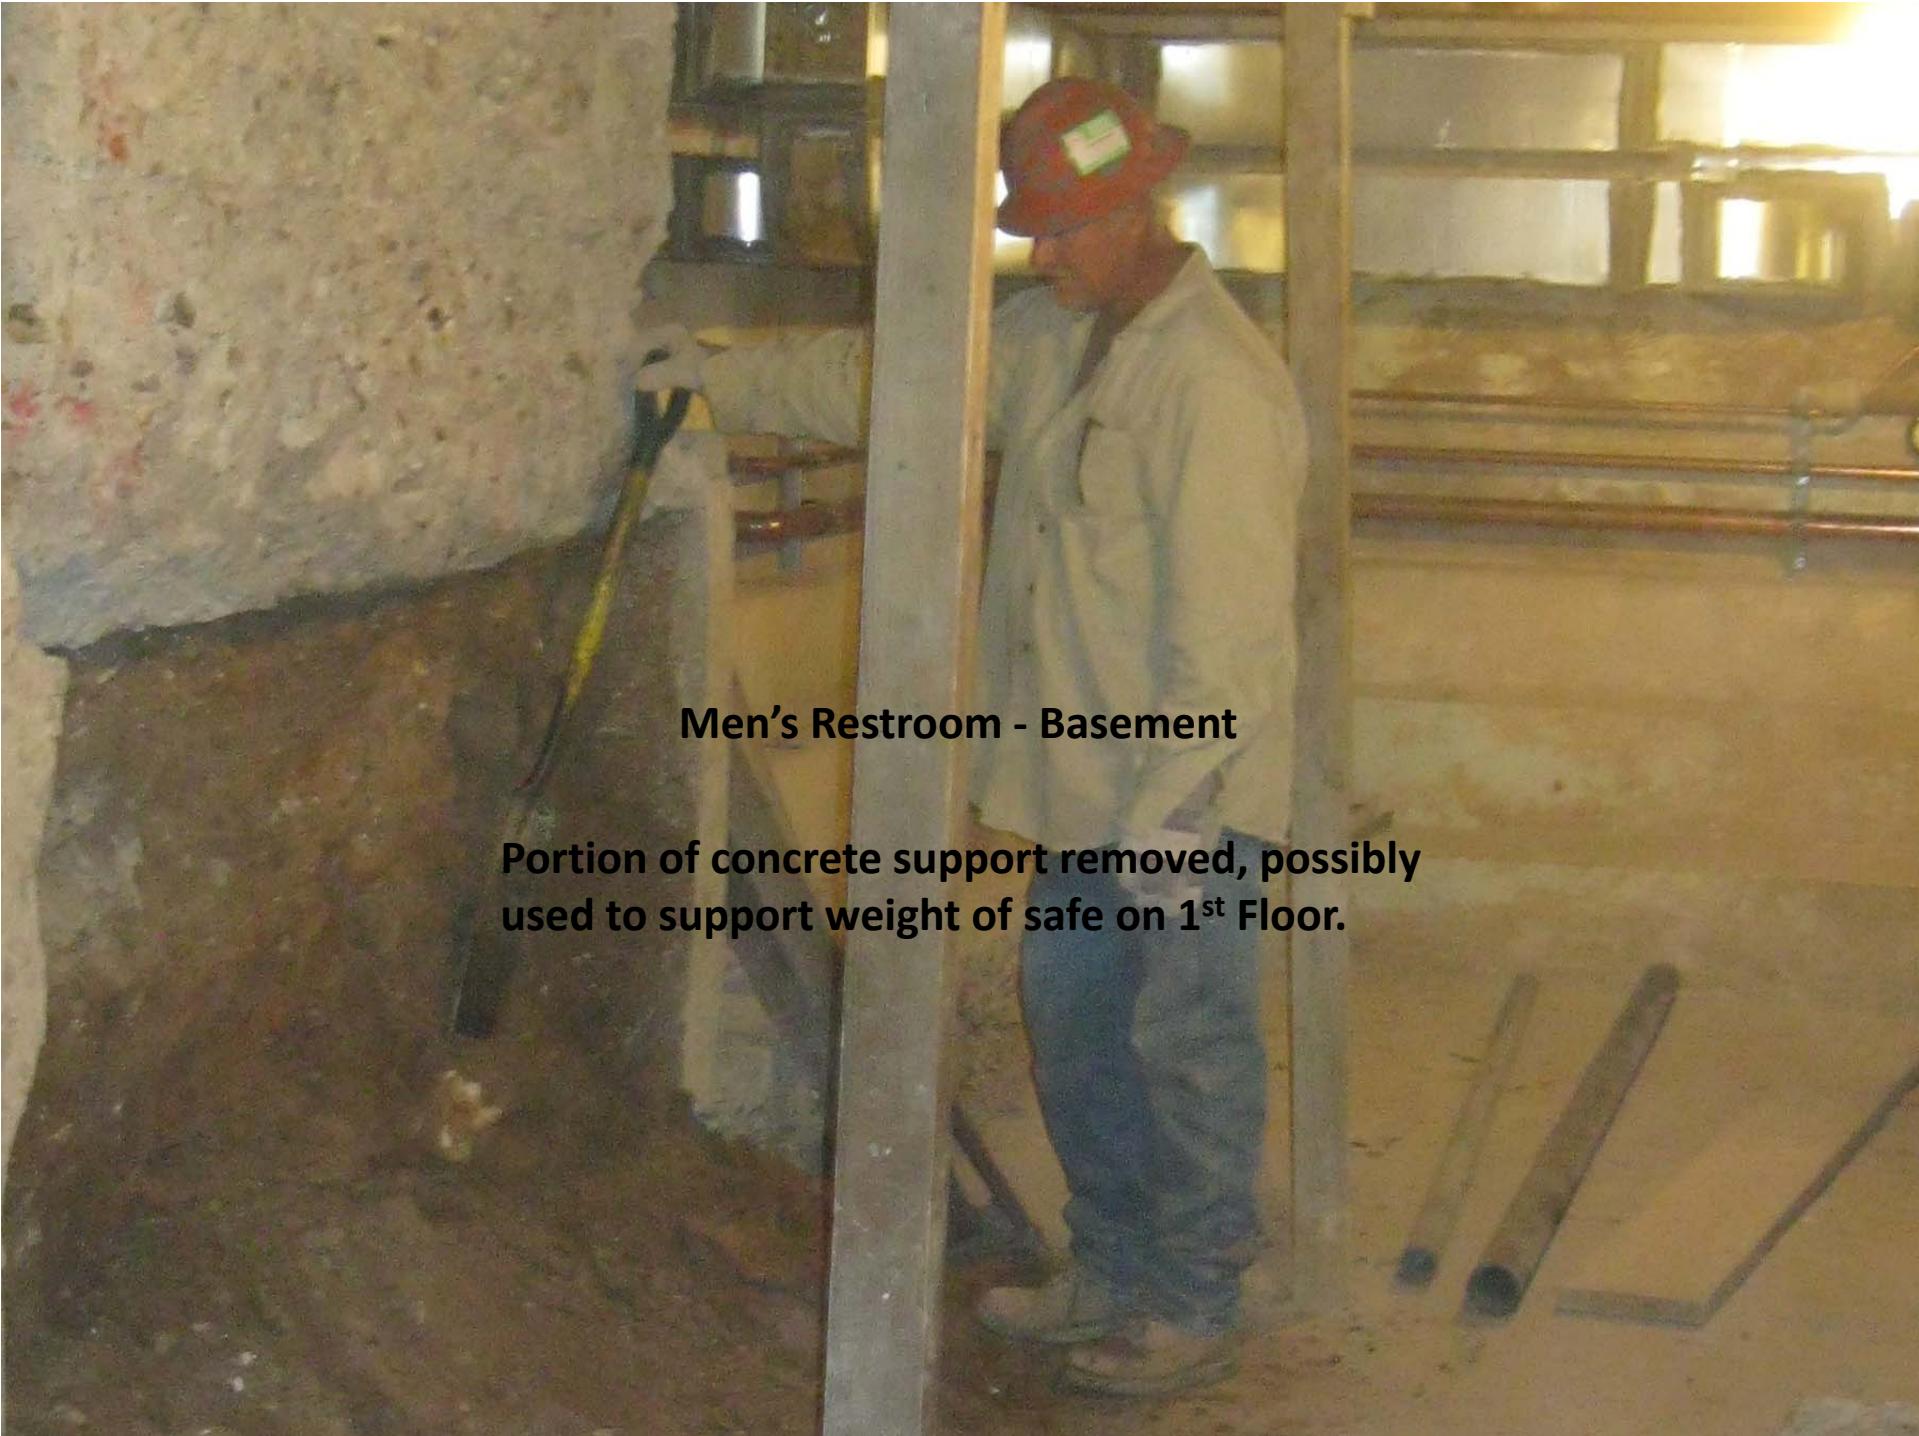
**Portion of concrete support removed, possibly
used to support weight of safe on 1st Floor.**

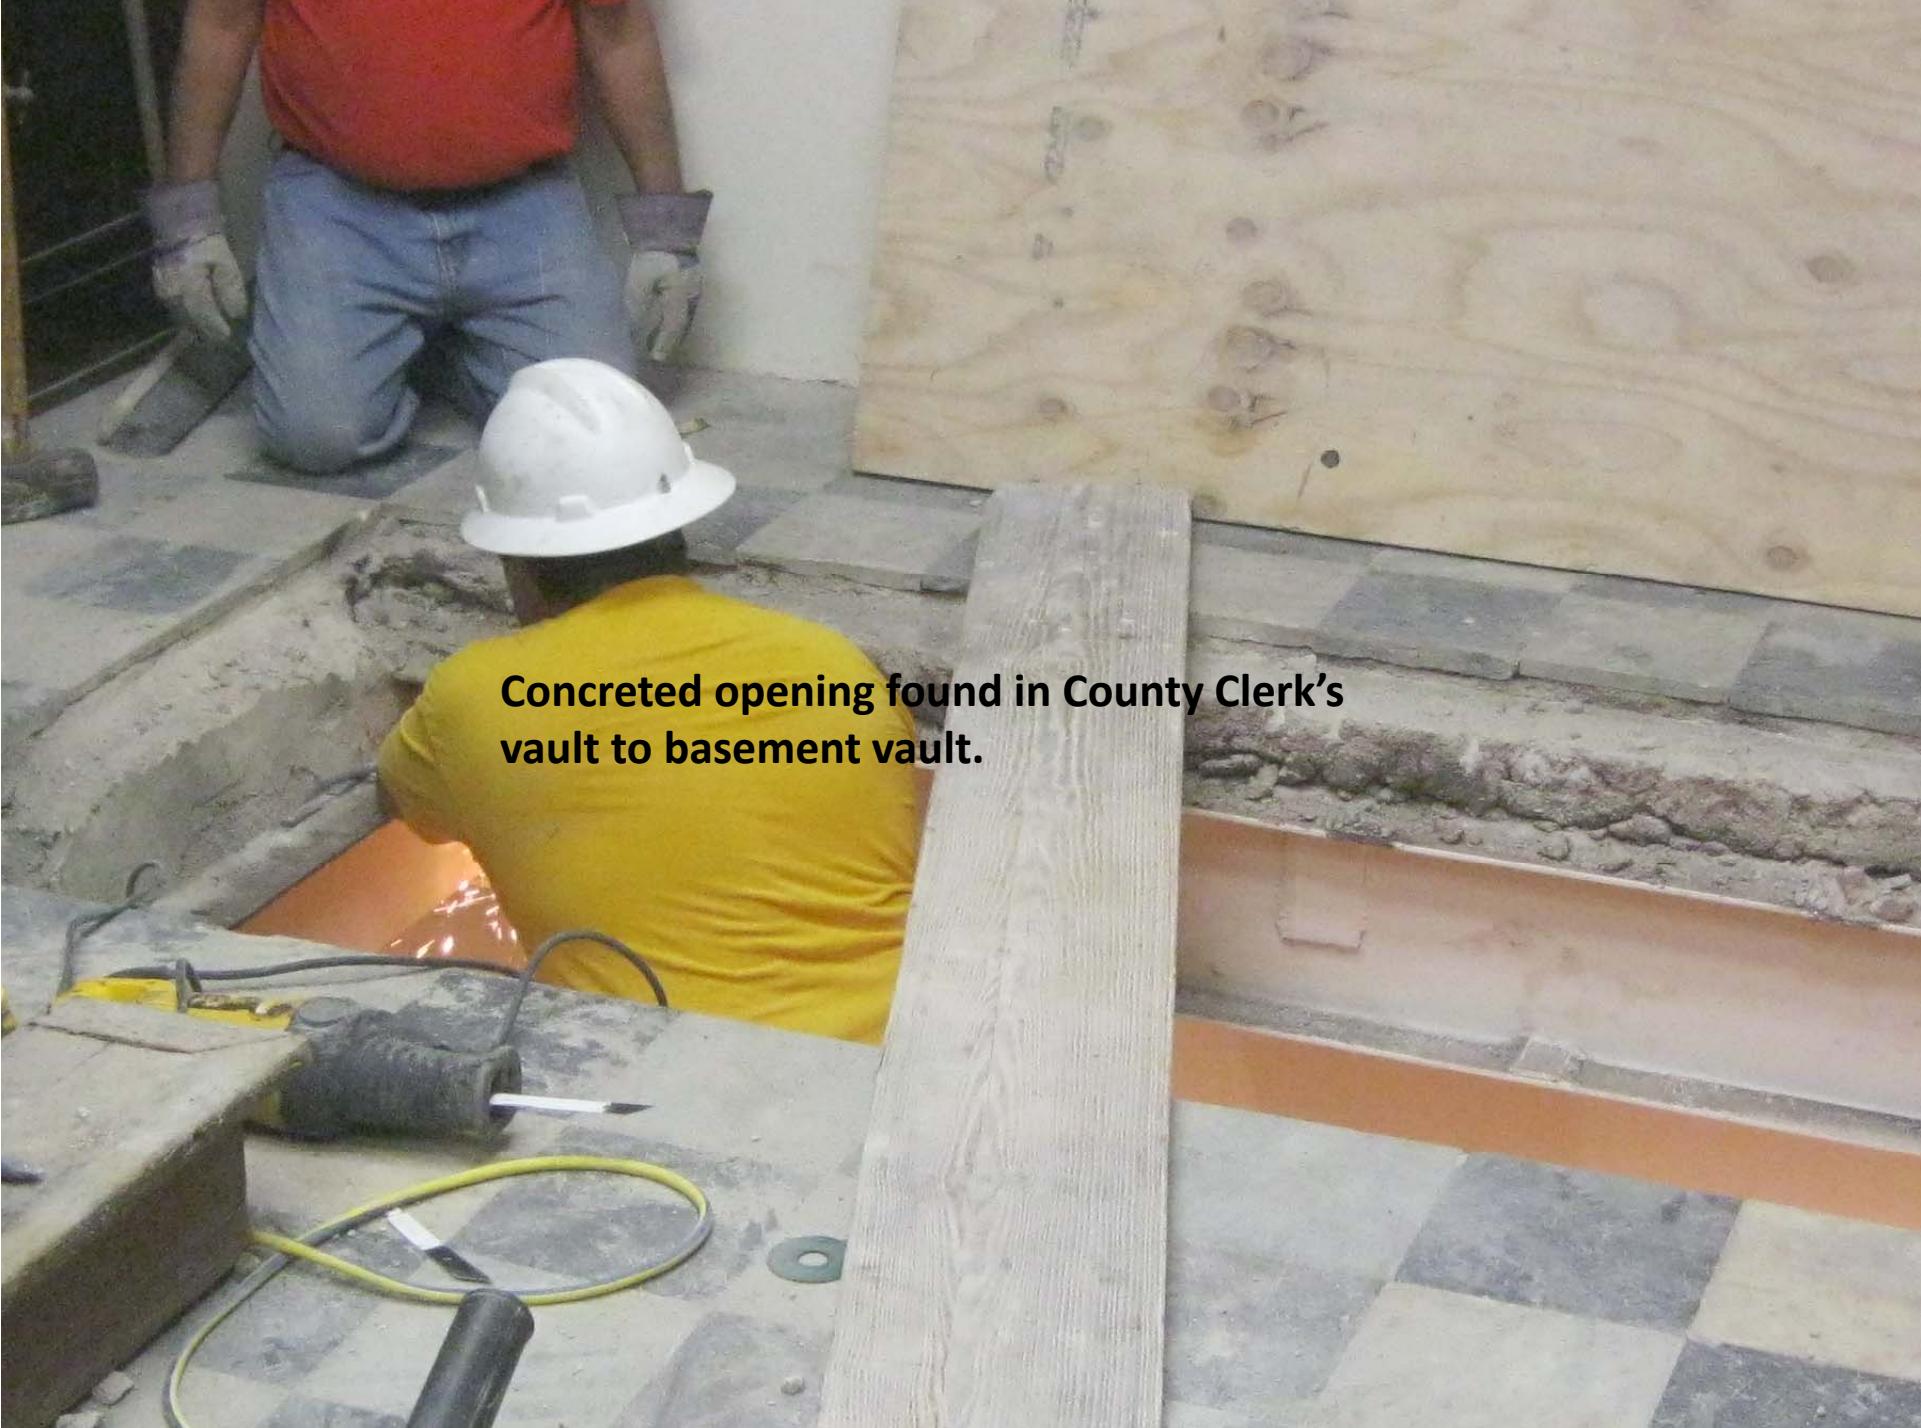
**Concreted opening found in County Clerk's
vault to basement vault.**
